**UNITED STATES ENVIRONMENTAL PROTECTION AGENCY
REGION 8**

Subject: Libby Asbestos Superfund Site
Operable Unit 5 – Former Stimson Lumber Property
Wood Chip Piles

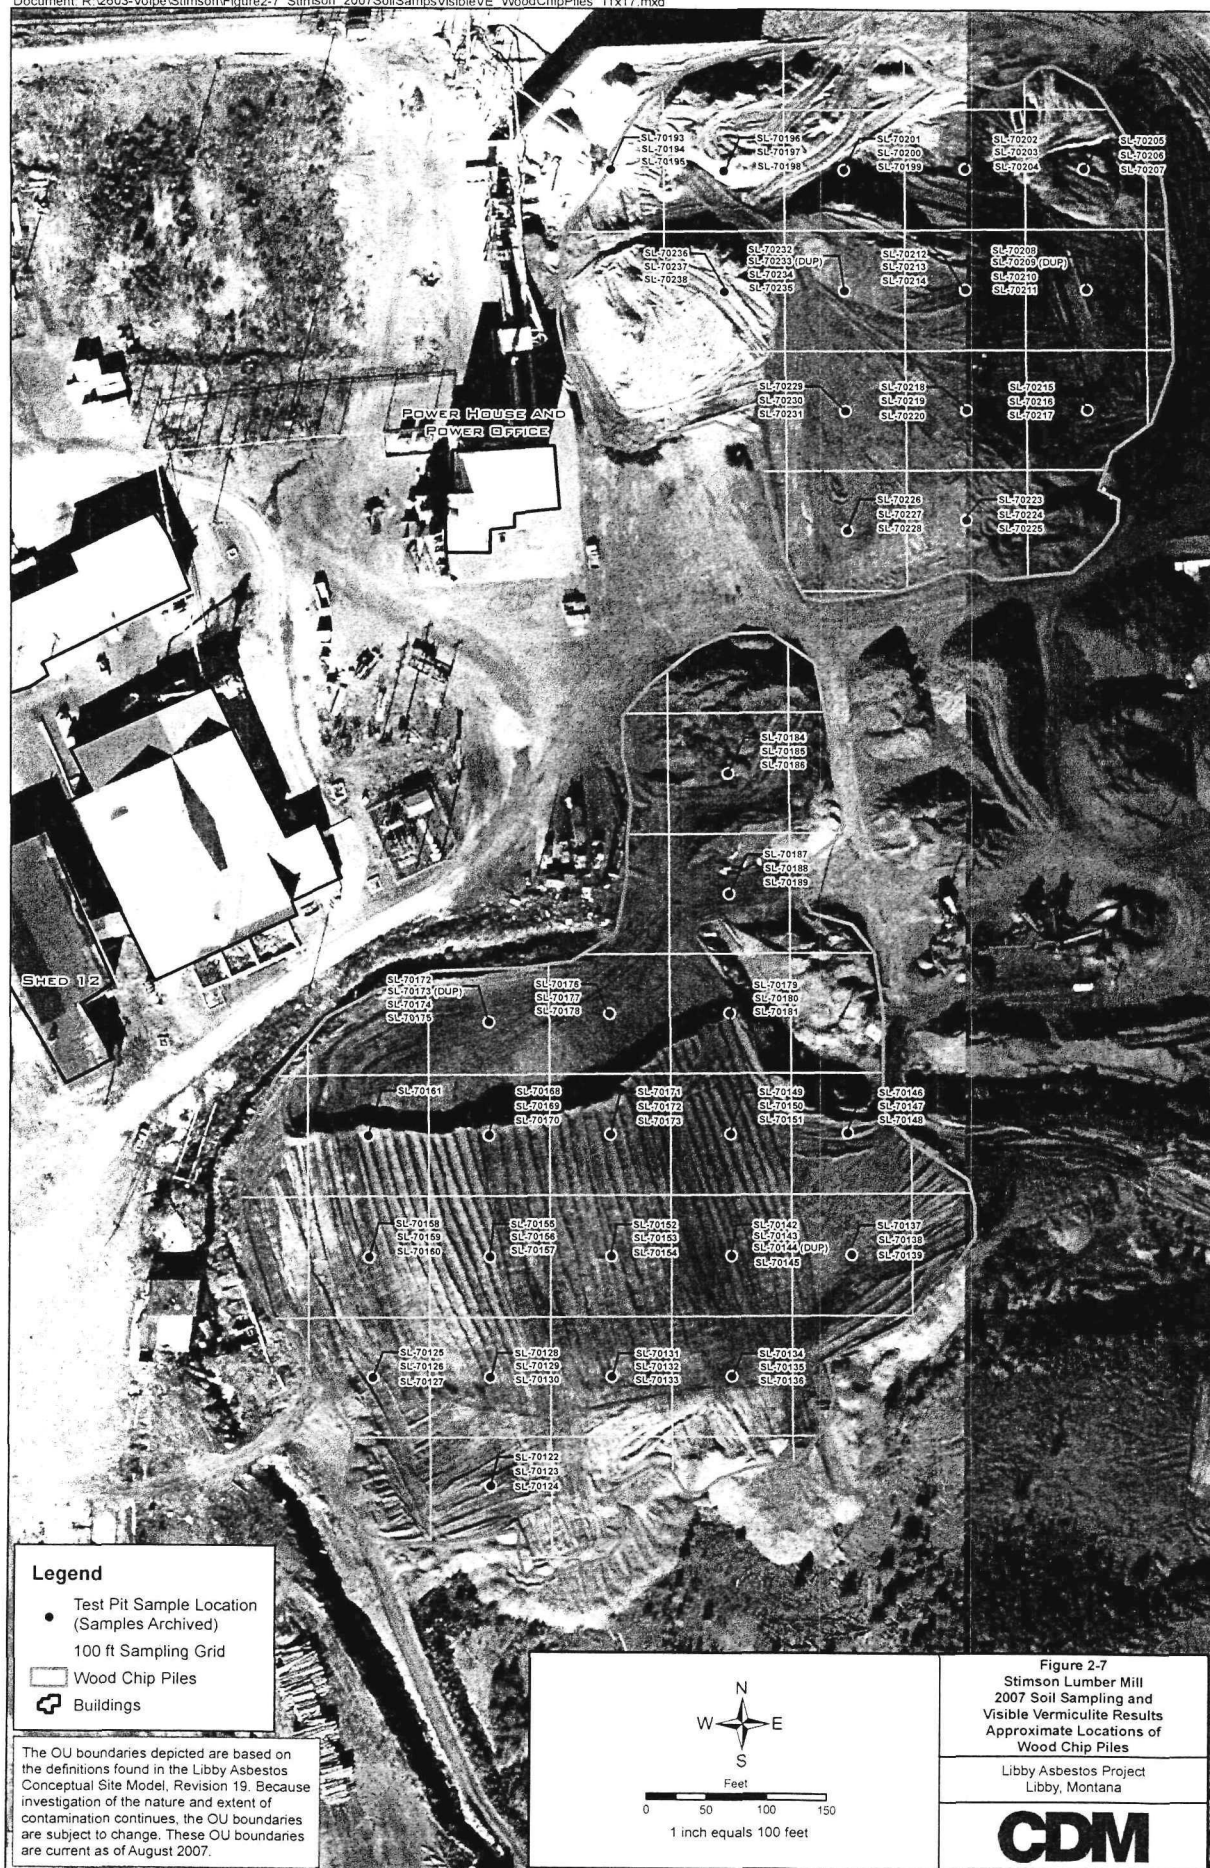
In 2007, EPA collected a number of bulk samples from the top, middle, and bottom sections of the wood chip piles. Figure 2-7 (enclosed) shows the locations where samples were collected. Twenty (20) samples were analyzed qualitatively for Libby Asbestos (LA) using both Polarized Light Microscopy (PLM) and Transmission Electron Microscopy (TEM).
